Site Accessibility Evaluation

Gateway Park

425 Janette Ave
Gateway, TN 37072

Inspection Date: 12/18/2017
Inspector: Shelley Zuniga

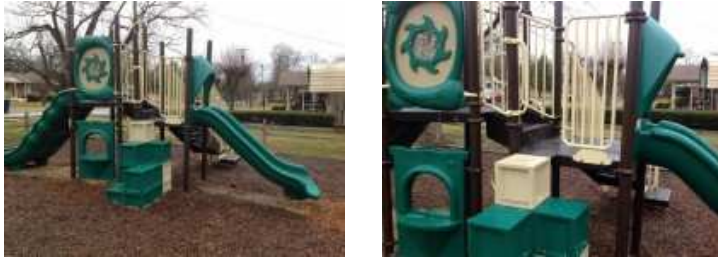
Finding #1, Additional Finding Photos

Finding Number	Area Description	Lat/Long	Finding	As Built	Recommendation	Citation	Phase	Photo	Figure
1	Play Area	36.2870530000/ -86.7152480000	Element meets all standards and requirements	5 of 5 comply by transfer	None	2010 ADAS Section: 240.2.2, 1008.4	N/A
